Radiation Portal Monitor Maintenance Guide for Rapiscan

October 2021
Revision 3.1

Office of Defense Nuclear Nonproliferation
National Nuclear Security Administration
U.S. Department of Energy

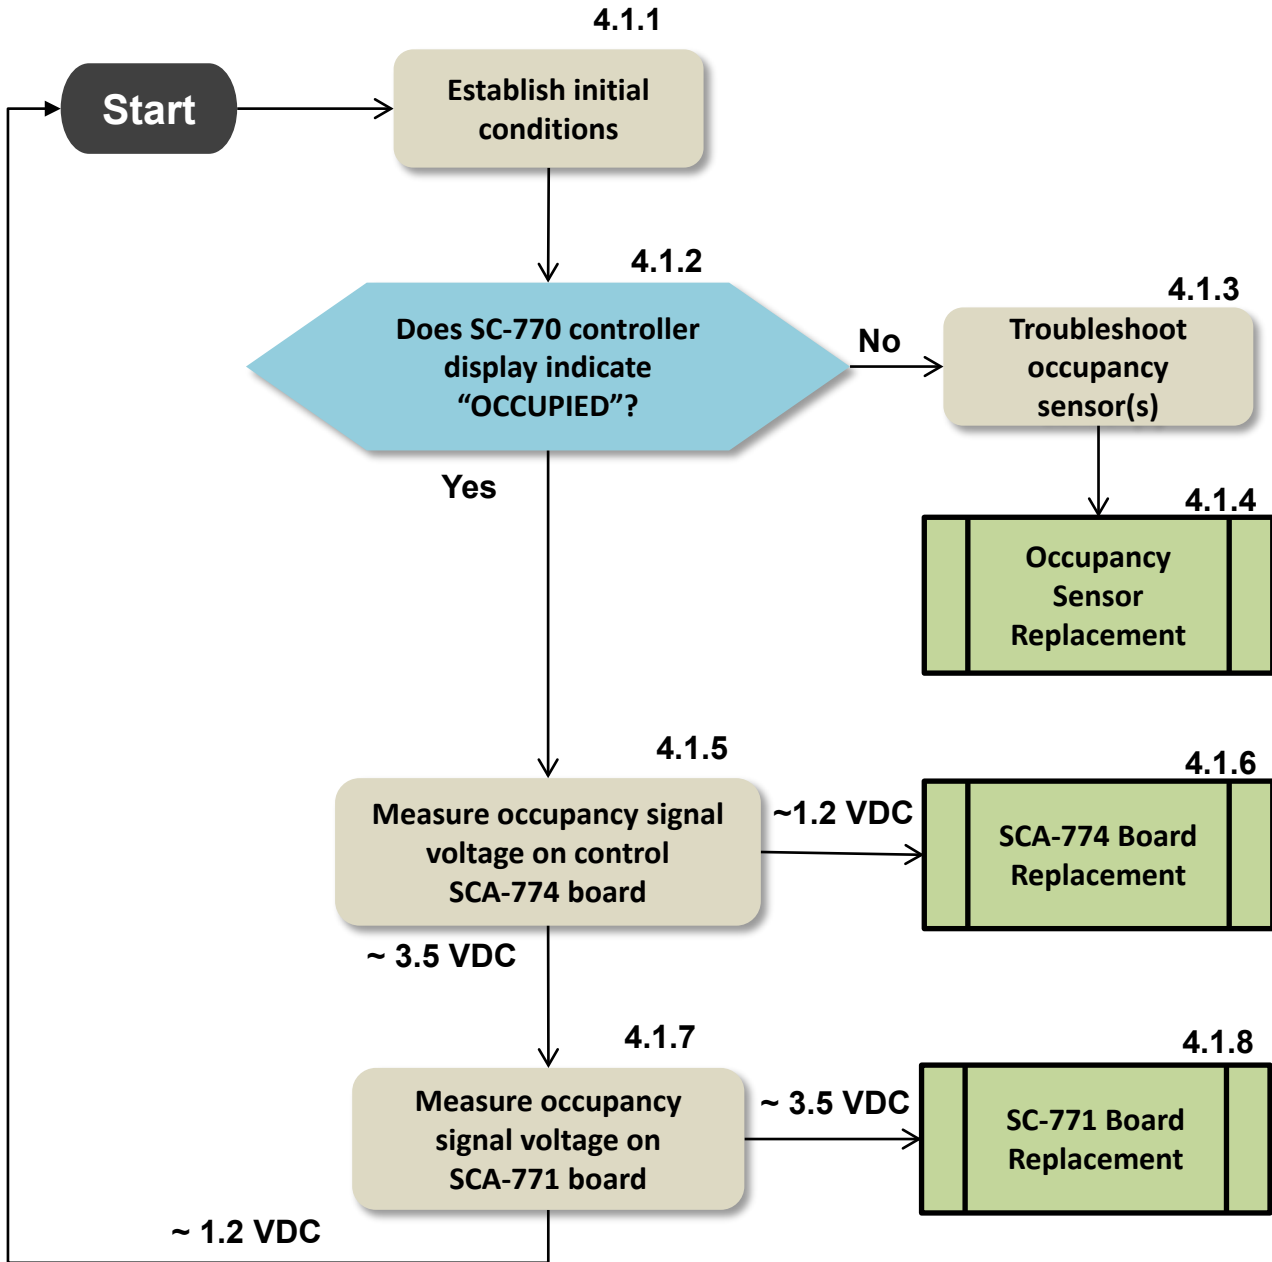
4.1 PM Constant Occupancy

Pedestrian Monitor Constant Occupancy Troubleshooting Notes:

<p>4.1.1</p>	<p>Establish Initial conditions for troubleshooting:</p> <ol style="list-style-type: none"> 1. Disable the door tamper switch with a magnet (or piece of tape for spring loaded tamper switch). 2. Disable Spy-2 or Wizard Dual Technology sensor by disconnecting green occupancy signal wire (going to SCA-775 module) on TB2 pin 6 (in control pillar). 3. In rare cases, there may be a second occupancy sensor in the auxiliary pillar of a pedestrian monitor, in that case, also disconnect the occupancy signal wire (going to SCA-775 Module) in the auxiliary pillar at TB4 pin 8 (in auxiliary pillar). 	
<p>4.1.2</p>	<p>Determine if the SC-770 display still shows OCCUPIED.</p> <ol style="list-style-type: none"> 1. If it still displays “OCCUPIED” go to step 4.1.5. 2. If it DOES NOT display “OCCUPIED”, go to step 4.1.3.

<p>4.1.3</p>	<p>If disconnecting the occupancy signal wire in step 4.1.1 cleared the occupancy, the problem is likely in the occupancy sensor. Reconnect the occupancy signal wire and carefully verify that the area in front of the sensor is clear of all people and obstacles. If the SC-770 controller again displays “OCCUPIED”:</p> <ol style="list-style-type: none"> 1. If the installed occupancy sensor is a Spy-2, go to step 4.1.4. 2. If the sensor is a Wizard Dual Technology sensor, attempt to adjust the sensors field of view per DET-RPM-RAP-CM16, <i>RPM Wizard Dual Tech Occupancy Sensor Replacement</i>. If that adjustment is not successful, go to step 4.1.4.

<p>4.1.4</p>	<p>Replace the occupancy sensor per:</p> <ol style="list-style-type: none"> 1. If the installed occupancy sensor is a Spy-2, replace the sensor with a spare Spy-2, or if one is not available, replace it with a Wizard Dual Technology sensor, per DET-RPM-RAP-CM15, <i>RPM Wizard Dual Tech Occupancy Sensor Replacement</i>. 2. If the sensor is a Wizard Dual Technology sensor, perform DET-RPM-RAP-CM16, <i>RPM Wizard Dual Tech Occupancy Sensor Replacement</i>. 	
<p>4.1.5</p>	<p>In the affected pillar(s), measure the occupancy signal output from the SCA-774 board at connector J10 Pin 1 (green wire)</p> <ol style="list-style-type: none"> 1. If the voltage measured is ~1.2 VDC (occupied), proceed to step 4.1.6. 2. If the voltage measured is ~3.5 VDC (not occupied), proceed to step 4.1.7.

<p>4.1.6</p>	<p>Before replacing the SCA-774 board, verify that the occupancy signal input to the SCA-774 board indicates “not occupied”. This is measured at SCA-774 board connector J11 Pin 4 (green wire).</p> <p>Occupied = ~0 VDC Not occupied = ~3.5 VDC</p> <p>If the input to the SCA-774 indicates “not occupied”, but the output indicates “occupied”, replace the SCA-774 board per DET-RPM-</p>

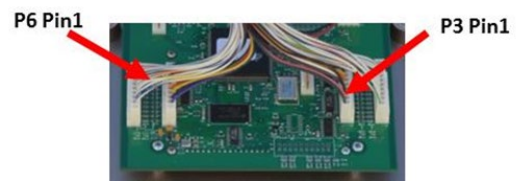
Measure the occupancy signal **input** voltage on the SC-771 board at two connectors.

1. If the voltage at P3 Pin 1, and P6 pin 1 are both ~3.5 VDC (not occupied), proceed to step 4.1.8.
2. If either voltage is ~1.2 VDC (occupied), go back to step 4.1.1.

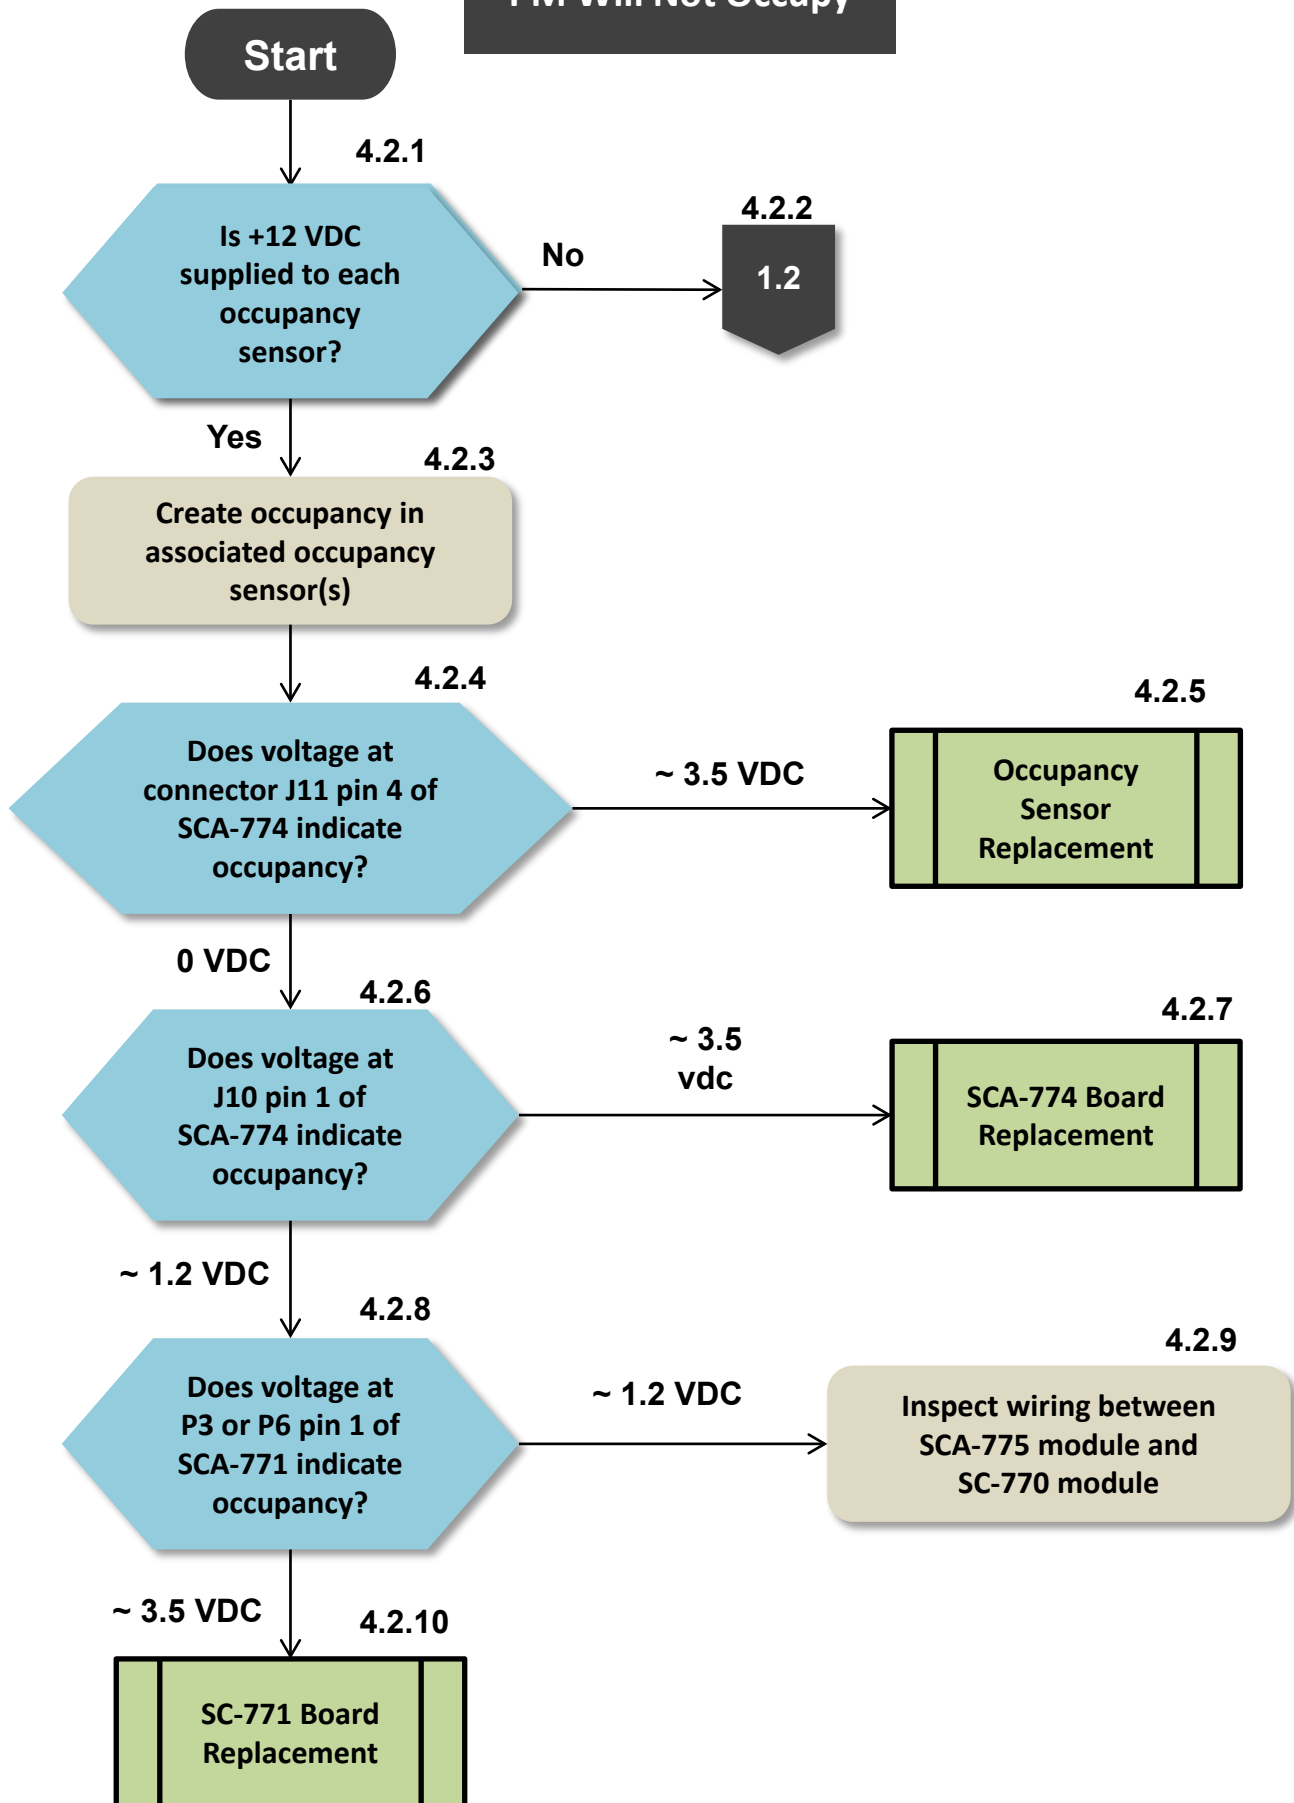
4.2 PM Will Not Occupy

Pedestrian Monitor will Not Occupy Troubleshooting Notes:

<p>4.2.1</p>	<p>Occupancy sensors require +15 VDC to function. +15 VDC is typically a red wire and ground is typically a black wire and +15 VDC sections are typically jumpered together with amber colored jumpers. The exact pin location of the +15 VDC and ground does not matter as long as it is actually +15 VDC or ground. If there is an occupancy sensor in each pillar, +15 VDC must be measured in each pillar.</p> <ul style="list-style-type: none"> • Control pillar: Verify +15 VDC at TB-2 Pin 19. • Auxiliary pillar: Verify +15 VDC at TB-4 Pin 1. 	
<p>4.2.2</p>	<p>If the +15 VDC is not present but the rest of the RPM appears to be functioning normal, start tracing the +15 VDC back to the source looking for loose or disconnected wires by following Flowchart 1.2. Sometimes a ground fault will pull down the +15 VDC in certain sections of the RPM, disconnecting components is sometimes the only way to trace this.</p>

<p>4.2.3</p>	<p>Create an occupancy condition by placing a hand or other object in front of the sensor.</p>	
<p>4.2.4</p>	<p>In the applicable pillar, measure the occupancy signal input to the SCA-774 board at connector J11 Pin 4 (green wire).</p> <ul style="list-style-type: none"> • If the voltage measures ~3.5 VDC (not occupied), proceed to step 4.2.5. • If the voltage measures ~0 VDC (occupied), proceed to step 4.2.6.

<p>4.2.5</p>	<p>Perform DET-RPM-RAP-CM16, <i>PM Wizard Dual Tech Occupancy Sensor Replacement</i></p> <p>1. If the installed occupancy sensor is a Spy-2, replace the sensor with a spare Spy-2, or if one is not available, replace it with a Wizard Dual Technology sensor, per DET-RPM-RAP-CM15, <i>RPM SPY to Wizard Occupancy Sensor Installation</i>.</p> <p>2. If the sensor is a Wizard Dual Technology sensor, perform DET-RPM-RAP-CM16, <i>RPM Wizard Dual Tech Occupancy Sensor Replacement</i>.</p>

<p>4.2.9</p>	<p>Inspect the wiring and connectors between the SCA-775 and SC-770 module.</p>	
<p>4.2.10</p>	<p>Perform DET-RPM-RAP-CM09, <i>RPM SC-771 Controller Board Replacement</i>.</p>

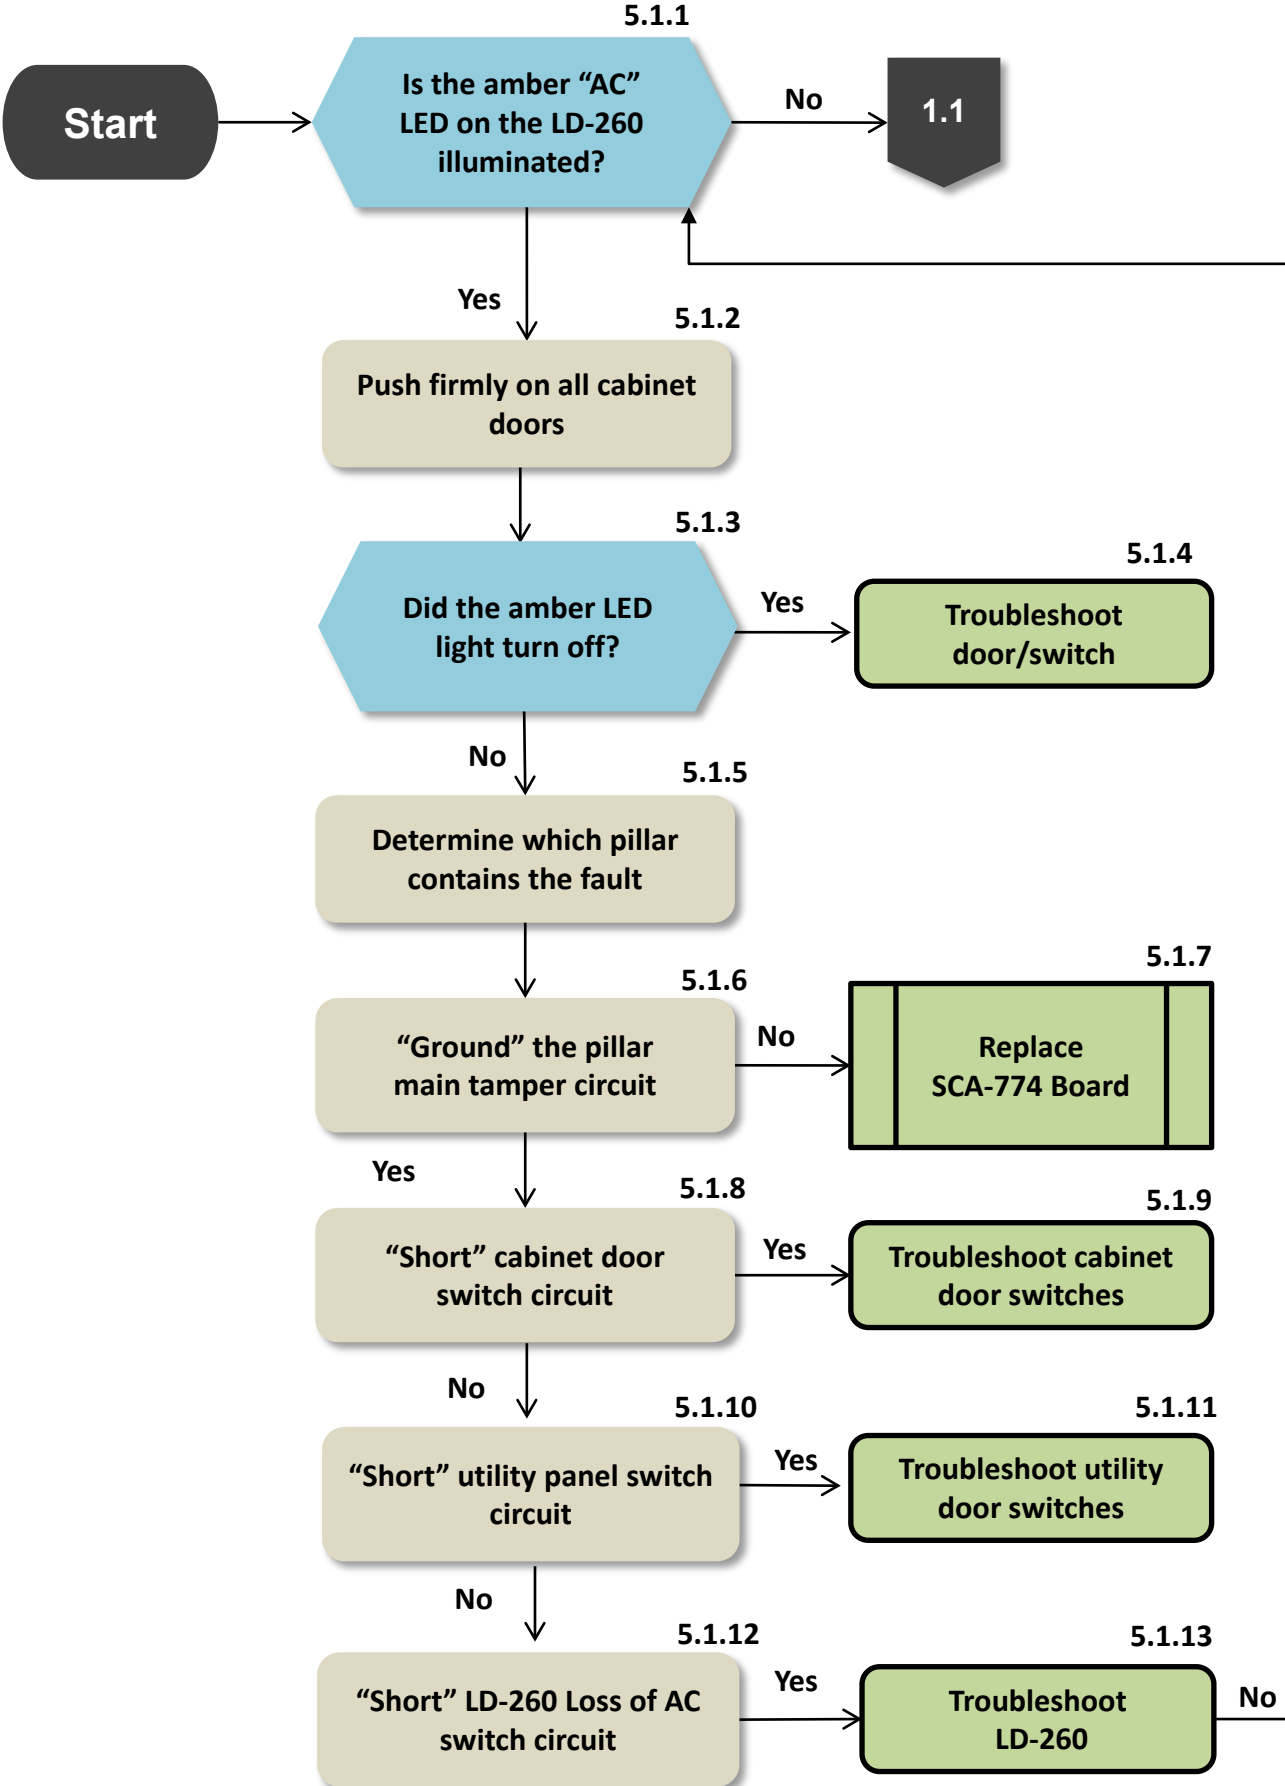
5.1 Cabinet Tamper

Tamper Circuitry Troubleshooting Notes:		
5.1.1	<p>A “tamper fault” indication in this case requires that there is a “TAMPER” indicated on the SC-770 controller or on the CAS user interface.</p> <ul style="list-style-type: none"> • If the amber “Fault” LED on the control pillar is illuminated but the fault is not indicated on the SC-770 controller or CAS user interface, proceed to section 6.1 “Local Alarm Indication.” • If a tamper fault is indicated on the CAS interface but the amber LED on the control pillar is not illuminated, check the “RELAY OUTPUT” parameter on the SC-770 controller and ensure that the local alarm/fault indicators are “ON” (enabled). <p>A tamper fault can be caused by either a loss of AC power or an open cabinet tamper switch.</p> <ol style="list-style-type: none"> a. If the amber “AC” LED on the LD-260 is not illuminated troubleshoot the Loss of AC Power in Section 1.1. b. If the amber “AC” LED on the LD-260 is illuminated, proceed to 5.1.3.

5.1.2	<p>A cabinet tamper fault condition is often caused by a loose cabinet door latch. Close all RPM cabinet doors. While watching the amber fault light on the control pillar, push firmly on the RPM cabinet doors.</p>

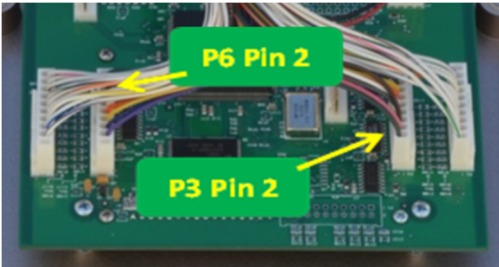
5.1.5	<p>Determine which pillar is generating the tamper fault: Measure the voltage on the tamper circuit inputs to the SC-771 board (inside the SC-770 controller). The control pillar tamper signal can be measured at P3, pin 2 (pink wire), and the auxiliary input at P6, pin 2 (pink wire).</p> <ul style="list-style-type: none"> • Tamper = ~3.9 VDC • OK = ~1.1 VDC <p>Troubleshoot the pillar that contains the fault starting with step 5.1.6.</p>

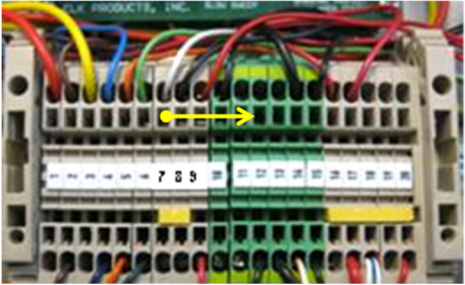
5.1.6	<p>Ground the main (white colored) tamper signal wire to the SCA-774 board from TB-2 pin 7 (control) or TB-6 pin 7 (auxiliary) directly to ground (any green terminal).</p> <ol style="list-style-type: none"> a. If grounding the white wire clears the tamper condition, go to step 5.1.8. b. If grounding the white wire does not clear the tamper condition, go to step 5.1.7.

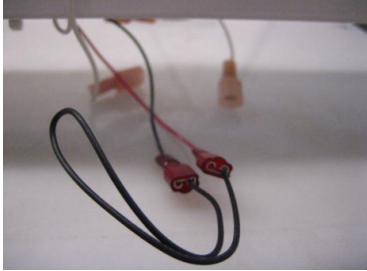
<p>5.1.8</p>	<p>In a vehicle monitor, place a jumper across control pillar TB-2 pin 8 & 9 or auxiliary pillar TB-6 pin 6 & 7, this removes the door tamper switches from the circuit.</p> <ol style="list-style-type: none"> If the tamper clears, troubleshoot the door switch starting with step 5.1.9, If the tamper does not clear go to step 5.1.10. 	
<p>5.1.9</p>	<p>Troubleshoot the door tamper switches one at a time by disconnecting the connectors and placing a jumper across the circuit. Placing a jumper across the circuit effectively bypasses the tamper switch. If bypassing a switch clears the fault, verify magnet/switch position and orientation. Repeat this for each door switch in the circuit. A jumper across the Molex connector in a vehicle monitor can rule out the lower two detectors.</p>

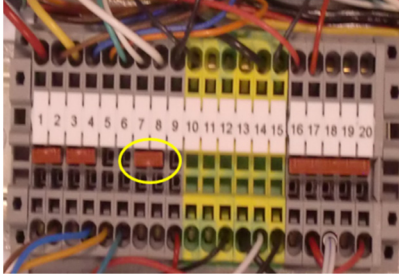
<p>5.1.10</p>	<p>If placing a jumper across each cabinet door switch does not clear the fault, short the utility panel door switch (if installed). If a utility panel tamper switch is wired through the control pillar, it will be connected across TB-2 pins 7 and 8.</p> <ol style="list-style-type: none"> If bypassing the switch clears the fault, proceed to step 5.1.11. If bypassing the switch does not clear the fault, proceed to step 5.1.12.

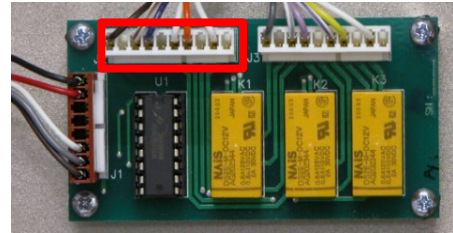
After POST and with no alarms or faults, the pins should have a voltage of ~12 VDC.

1. If the relay output voltages are correct, proceed to step 6.1.12.
2. If the relay output voltages are NOT correct, proceed to step 6.1.13.

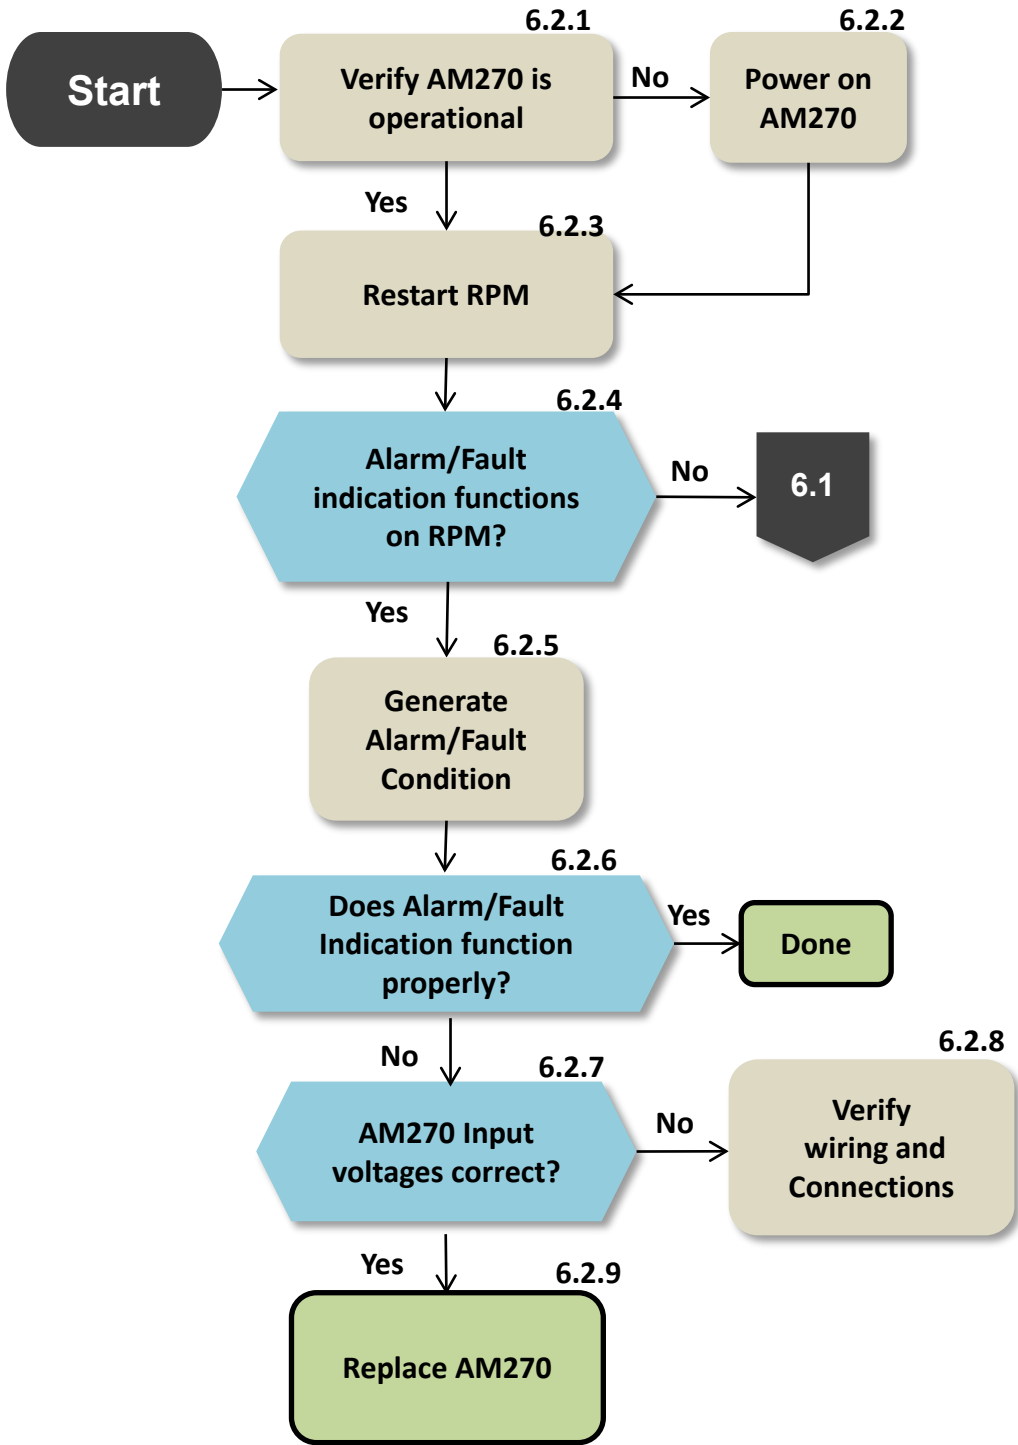
6.2 Remote Indications

Remote Alarm Panel Alarm/Fault Indication Troubleshooting Notes

6.2.1	<p>Verify AM270 is operational;</p> <ul style="list-style-type: none"> • The green “power” LED on the front panel will be illuminated to indicate that the battery is charged and connected, and the power switch is in the on position. • The “ready” LED shows that the system is clear of alarms/faults and working properly. • Press the AM-270 “TEST” button; this will cause all the alarm/fault LEDs to flash. If the key switch is in the “normal” position, it will also cause the audible alarm to sound.

6.2.5	<p>You should be at this point because an alarm or fault indication is functioning on the RPM control pillar (external) but not functioning on the remote alarm panel when a known alarm or fault condition exists (GA, NA, GH, GL, NH, TAMPER). Next:</p> <ol style="list-style-type: none"> a. Generate the alarm/fault condition in question per the RPM Operational Testing Procedure DET-RPM-RAP-RM03, <i>RPM Operational Testing Procedure</i>. b. Verify that the alarm/fault condition is indicated on the SC-770 controller display. c. Proceed to step 6.2.6.

6.2.6	<p>After generating the alarm or fault condition in question in step 6.2.5, does the alarm or fault indication in question function on the AM270?</p> <ol style="list-style-type: none"> a. If yes, troubleshooting is complete. a. If no, proceed to step 6.2.7.
